# PROPERTY INSPECTION REPORT

**SmartScan**  
Home Inspections

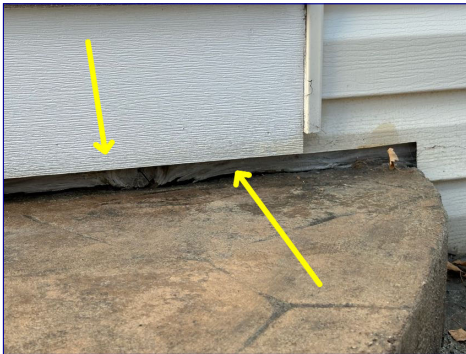
Recommend replacing the damaged wood. Monitor and consult a licensed pest elimination professional as needed.

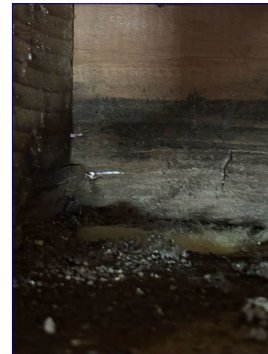
Wood rot continues all the way through rim joist. Can see the light from exterior on basement side.

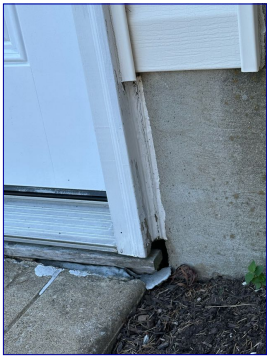
Page 20 Item: 13	Exterior Doors

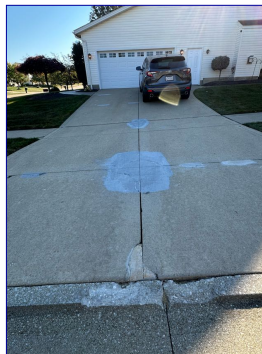
There are uneven slabs at the driveway, which could be a tripping hazard. Recommend using additional caution in these areas. Repair or replace as needed.

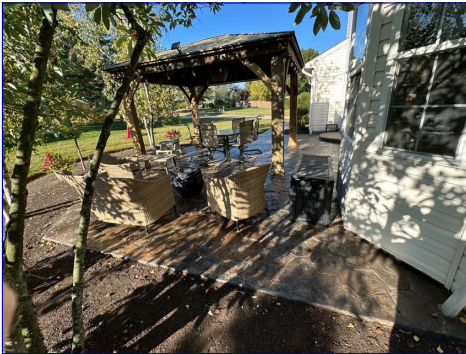
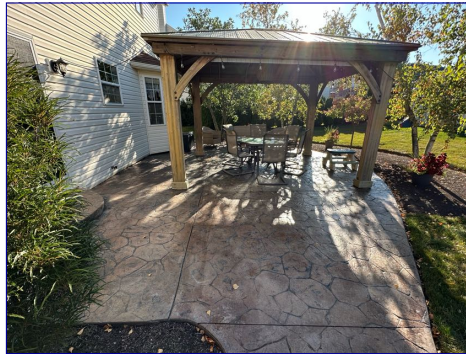
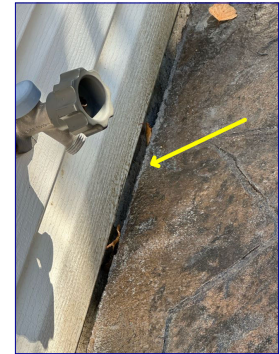
There is a gap between the patio and the house. Recommend sealing the gap to help prevent water penetration/ issues.

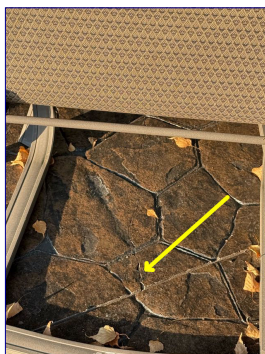
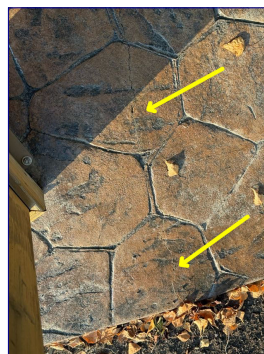
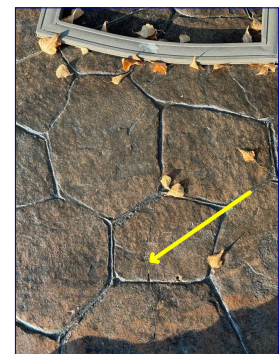
Crack that spans the length of the patio, from house to back yard. Currently no displacement, but recommend monitoring if movement happens, contact qualified Mason for repair.

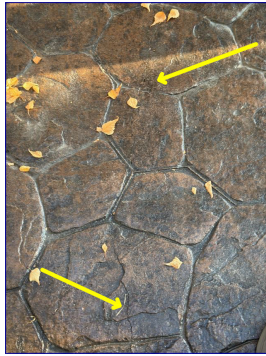
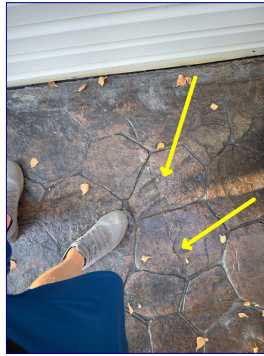
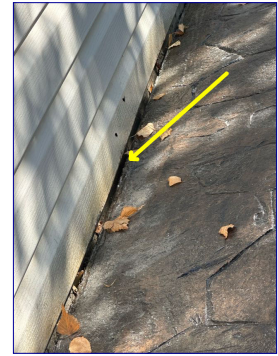
## 5. Deck/Porch/Patio Covers

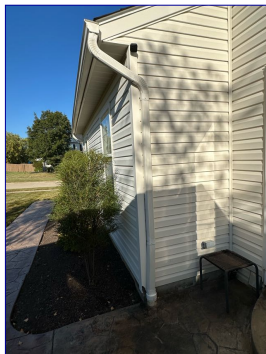
There is vegetation in contact with the house. Recommend trimming trees/vegetation, so it is doesn't come into contact with the home.

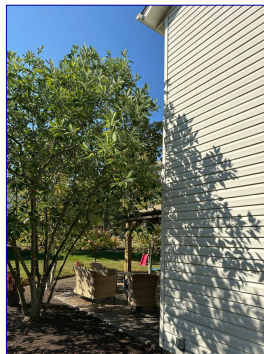
There is vegetation in contact with the house. Recommend trimming trees/vegetation, so it is doesn't come into contact with the home.

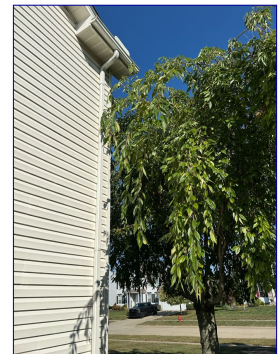
There is vegetation in contact with the house. Recommend trimming trees/vegetation, so it is doesn't come into contact with the home.

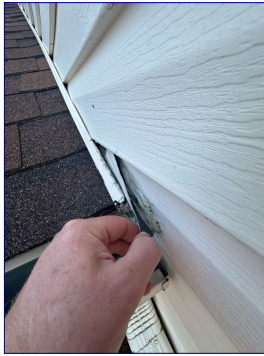
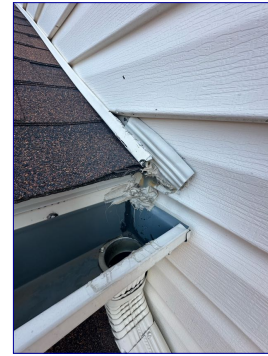
There are one or more areas of the roof flashing in need of sealing/repairs. Recommend a licensed contractor evaluate and repair or replace the flashing as needed.

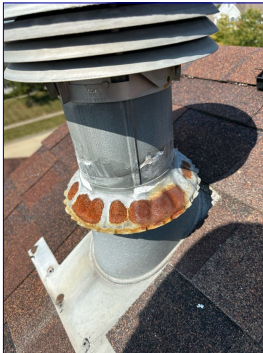
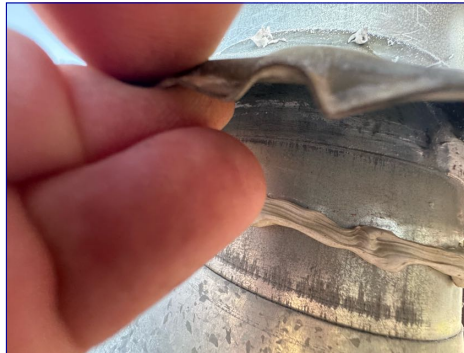
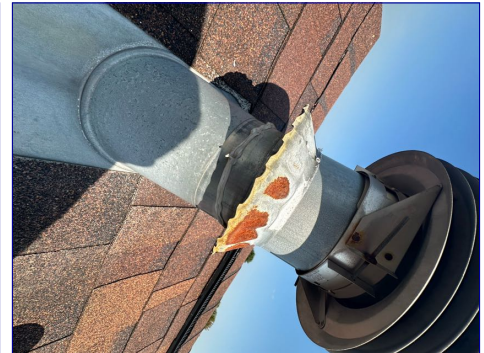
HVAC vent needs to be sealed. Caulk at flashing is missing. This will allow water into the home.

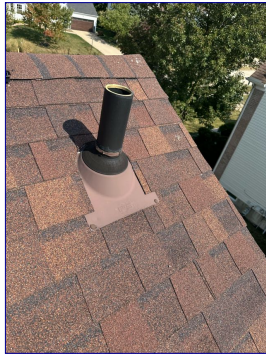
The Plumbing Vent(s)

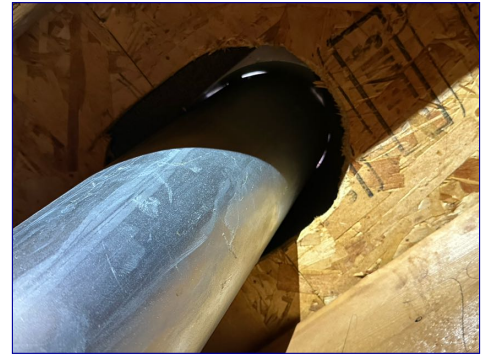
Light coming in from around the HVAC pipe going through the roof. Recommend resealing around the pipe to stop any water intrusion.

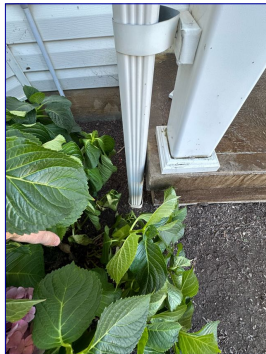
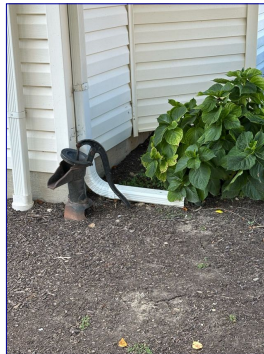
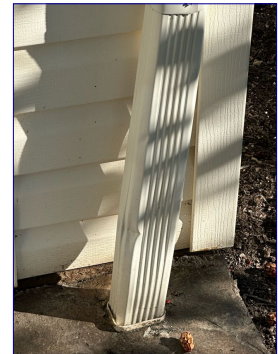
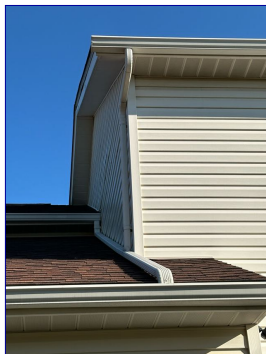
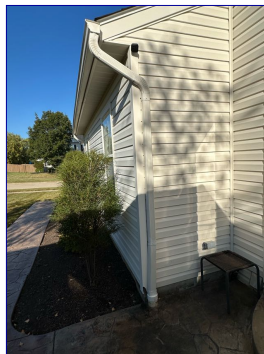
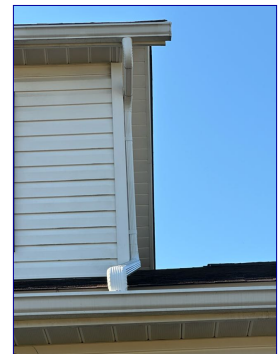
## Exterior (continued)

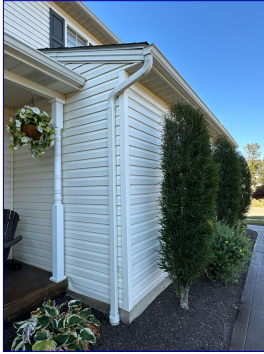
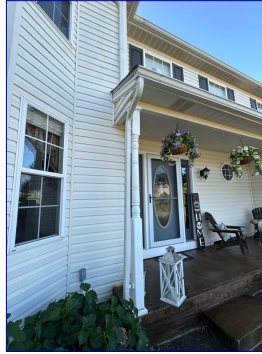
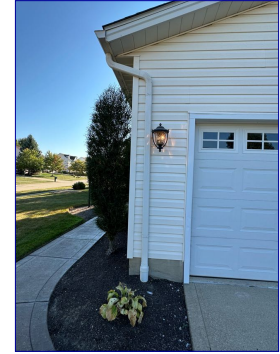
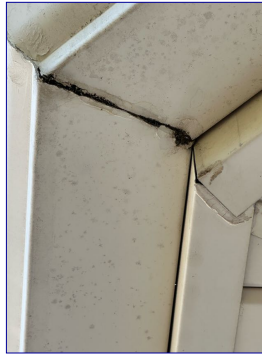
Gutter around dining room nook appears to be starting to rot. Monitor situation if leaking recommend gutter contractor to repair. Unable to assess due to no rain in the last few days.

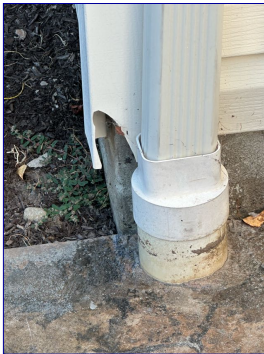
The siding had some damage, recommend a licensed contractor repair/replace damaged sections.

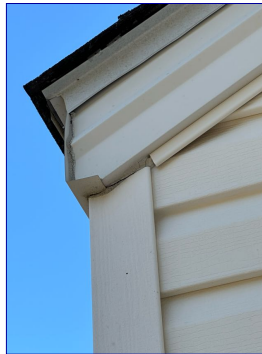
Where siding meets flashing needs caulked. Recommend routine caulking maintenance on the exterior of the home every other year.

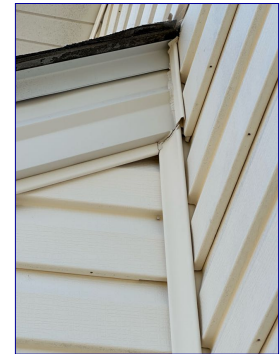
Where siding meets flashing needs caulked. Recommend routine caulking maintenance on the exterior of the home every other year.

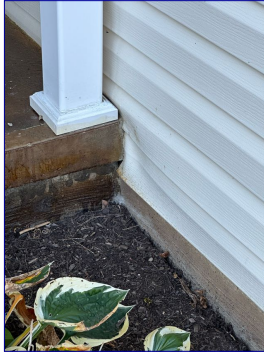
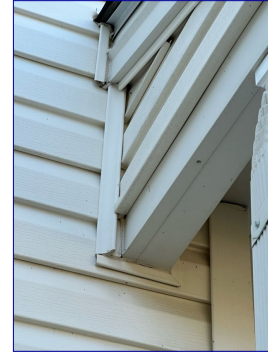
## Exterior (continued)

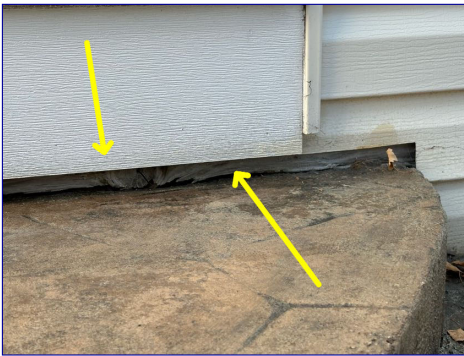
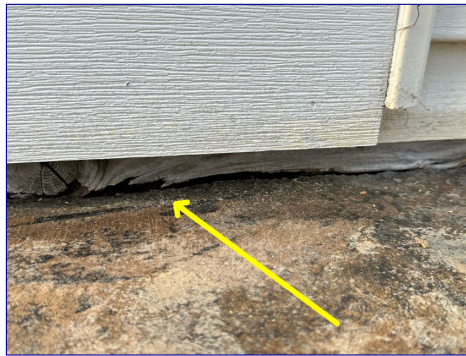
Recommend replacing the damaged wood. Monitor and consult a licensed pest elimination professional as needed.

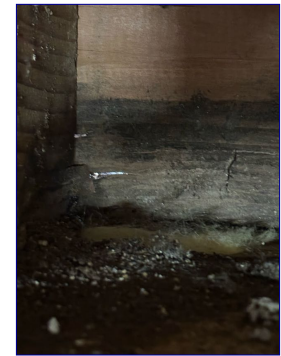
Wood rot continues all the way through rim joist. Can see the light from exterior on basement side.

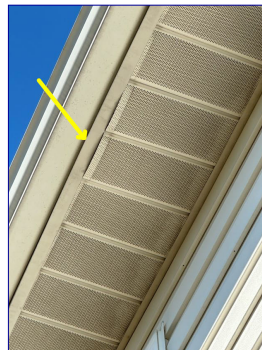
# Exterior (continued)

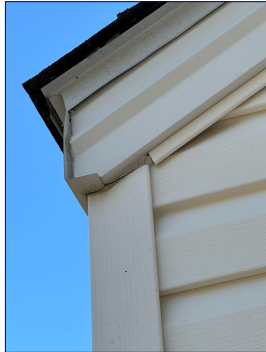
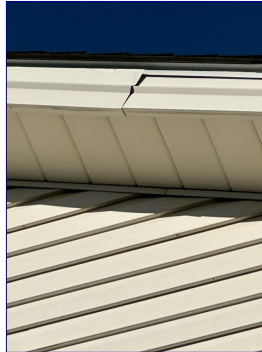
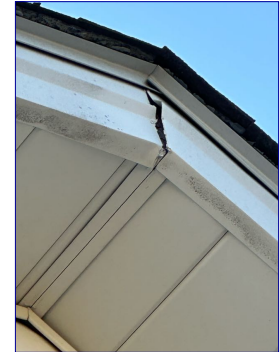
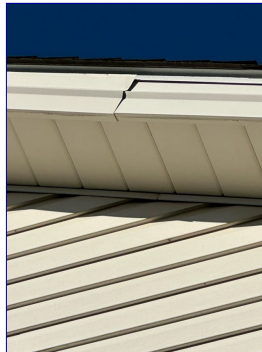
- The fascia is loose, recommending a licensed contractor re-secure.

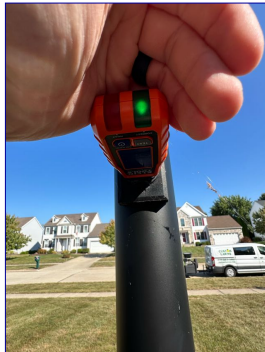
Outlet I'm front porch light.

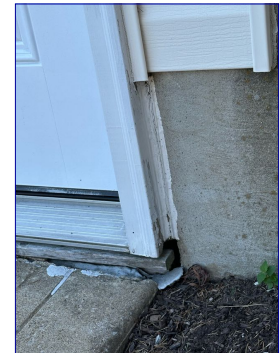
Garage man door has improper flashing/caulk. This can lead to water intrusion and potential wood destroy destroying organisms. Recommend replaced or repair by a qualified carpenter.

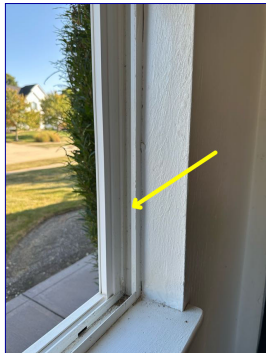
The left garage window is missing the restrictor cable. The window does not stay up and continues to fall down. This is safety issue recommend repair or replaced by window contractor.

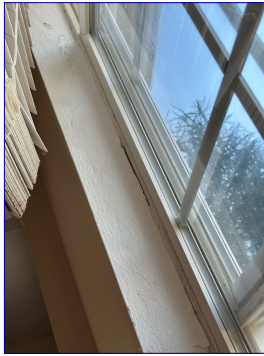
Missing caulk and peeling paint on the interior of the right garage window.

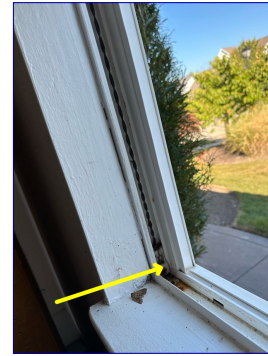
The right garage window is missing the restrictor cable. The window does not stay up and continues to fall down. This is safety issue recommend repair or replaced by window contractor.

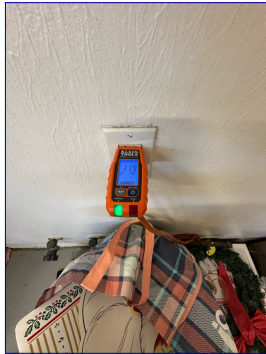
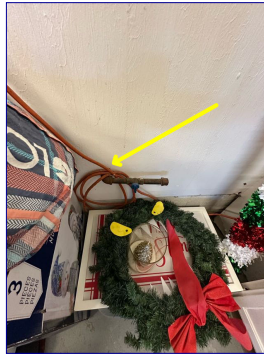
Extension cord wiring exists in the garage. Extension cords should never be used as permanent wiring. Recommend a licensed electrician repair.

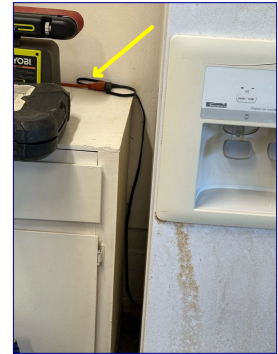
Extension cord wiring exists in the garage. Extension cords should never be used as permanent wiring. Recommend a licensed electrician repair.

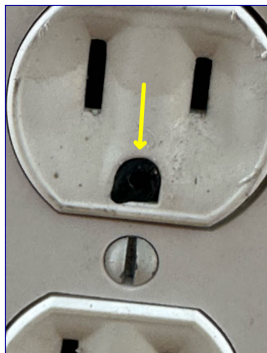
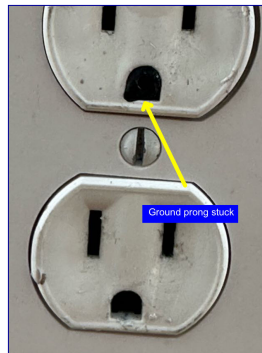
South wall plug has broken ground prong left in. This can cause a safety hazard for any other future appliances plugged into it. Recommend qualified electrician repair replaced the outlet.

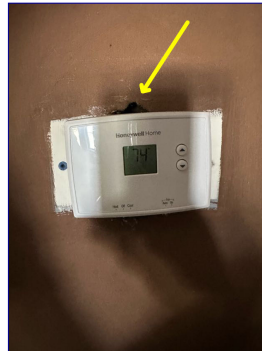
Drywall repair needed around thermostat.

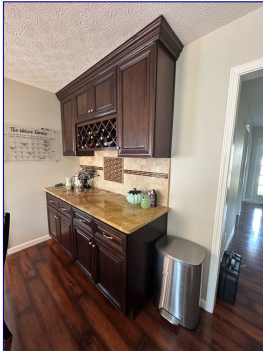
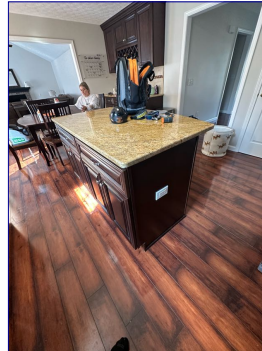
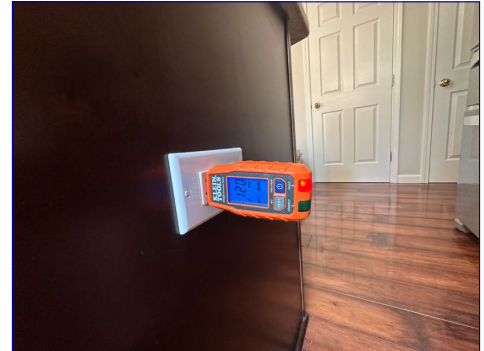
Outlet on kitchen island has an open ground. This is a potential safety hazard. Recommend repair replacement by a qualified electrician.

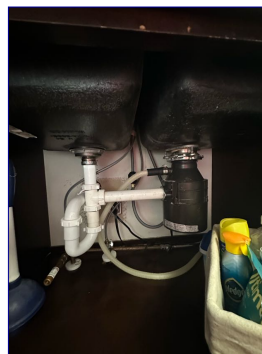
## 5. Walls & Ceiling

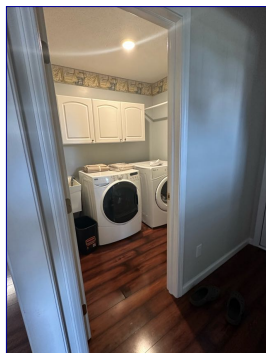
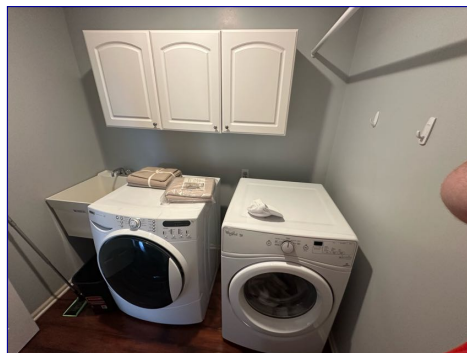
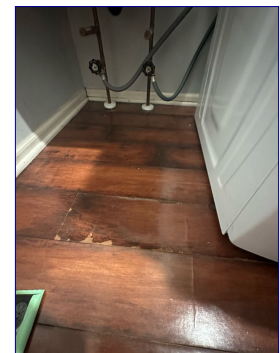
Signs of water damage on floor in laundry room. No currently leak evidence noticed.

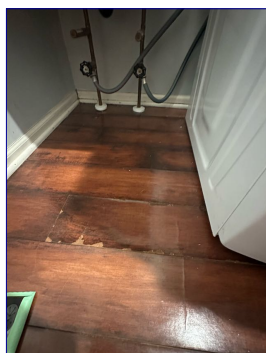
Signs of water damage on floor in laundry room. No currently leak evidence noticed.

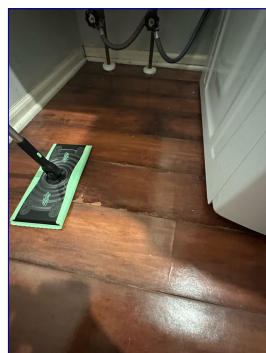
Signs of water damage on floor in laundry room. No currently leak evidence noticed.

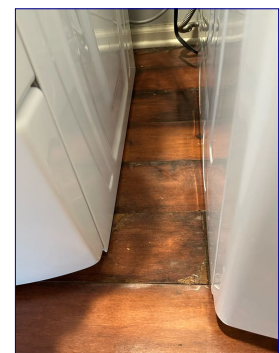
Signs of water damage on floor in laundry room. No currently leak evidence noticed.

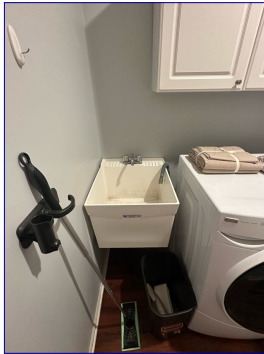
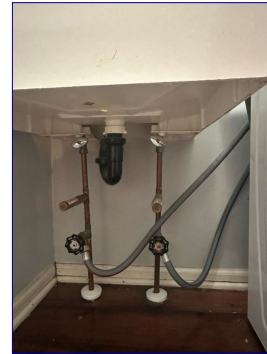
## 3. Heat Source Present

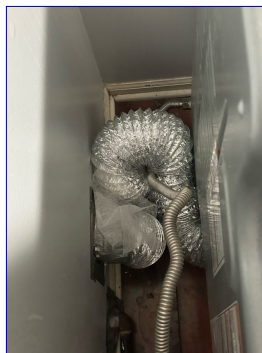
- Dryer vent hose has many sharp turns. This can cause accumulation of lint and present a potential fire hazard. Replace with appropriately fitting hose.

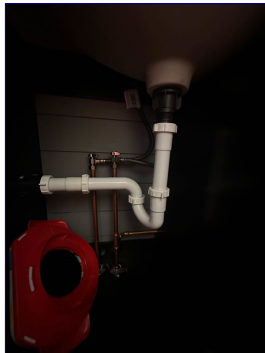
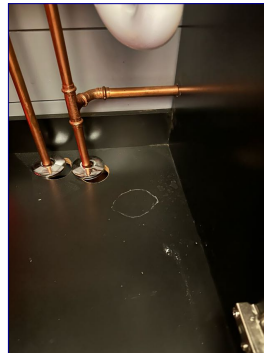
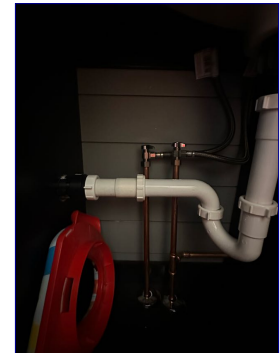
- Faucet leaks: No
- Pipes leak: No
- Observations:
- The bathroom plumbing view.

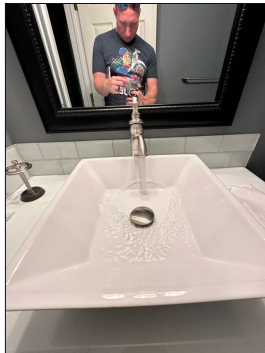
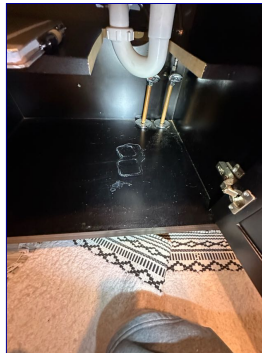
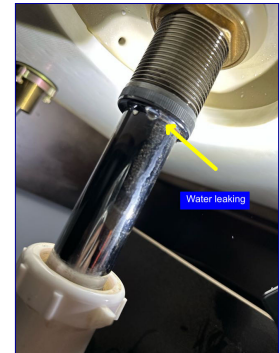
There was previous moisture staining and damage present under the bathroom vanity cabinet. Recommend monitoring. Repair or replace as needed.

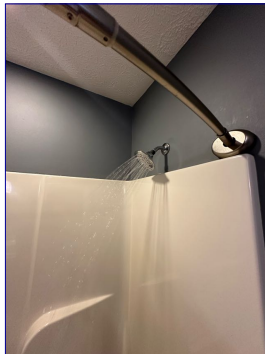
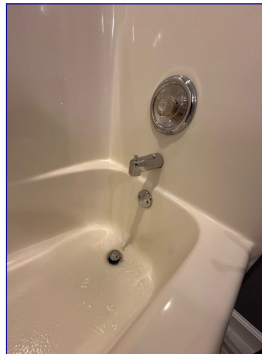
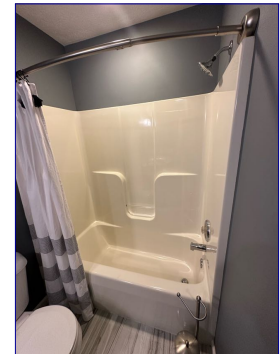
- Faucet leak: No
- Pipes leak: Not visible

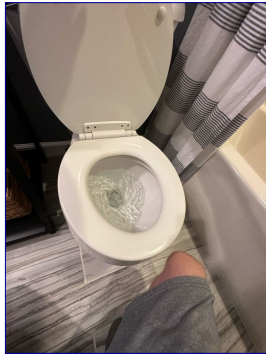
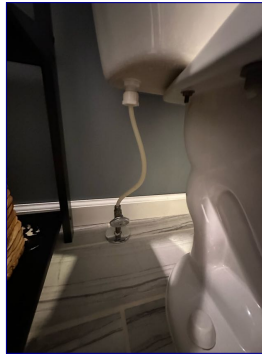
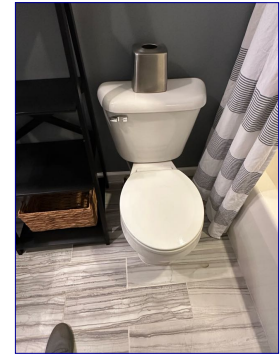
### 6. Shower/Bathtub Area

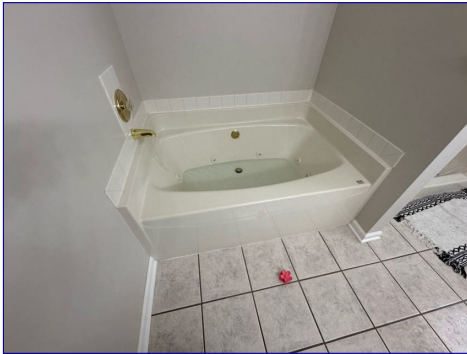
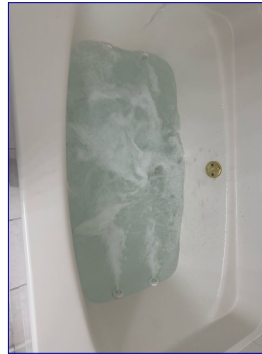
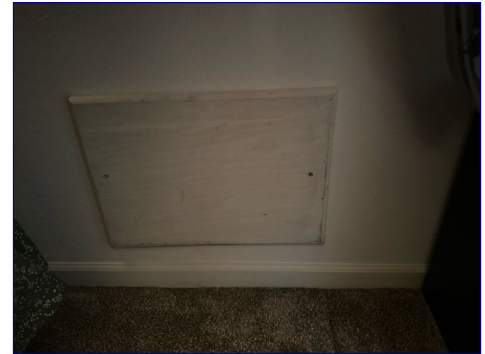
Jacuzzi tub access panel located in master walk-in closet.

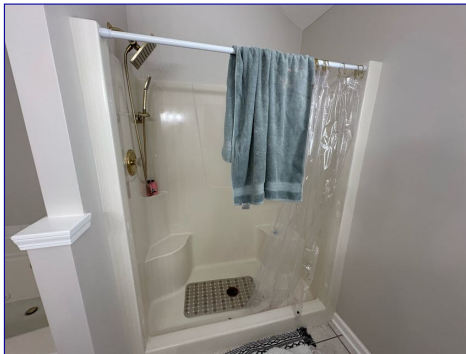
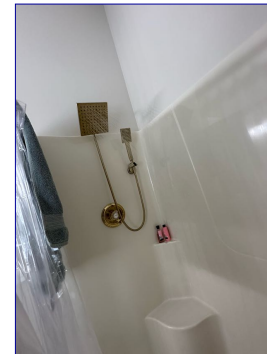
- Faucet leaks: No
- Pipes leak: Not visible

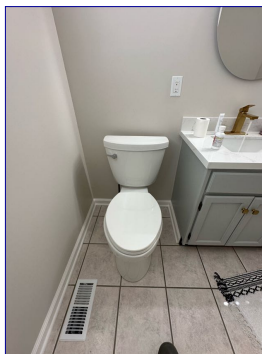
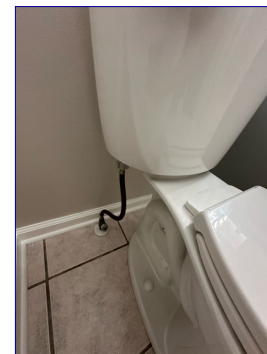
- Bowl loose: No
- Operable: Yes

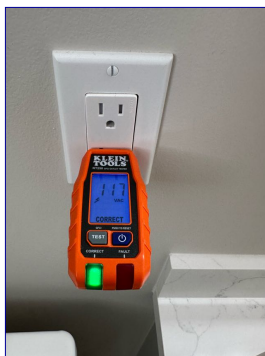
Outlet to the left of sinks is functioning properly and wired correctly.

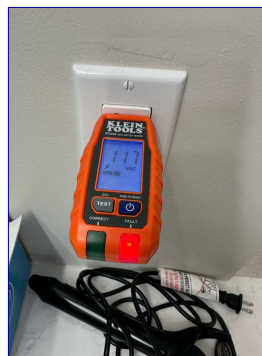
I went to the right of the sinks has an open ground. This is a safety hazard. Recommend correction by a qualified electrician.

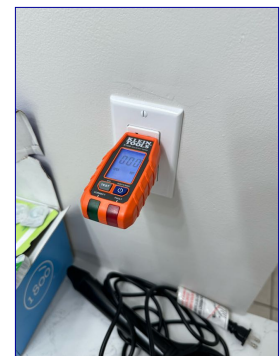
## 13. Heat Source Present

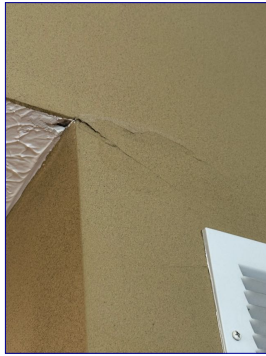
There are typical cracks on the walls/ceilings. Recommend drywall to repair as needed.

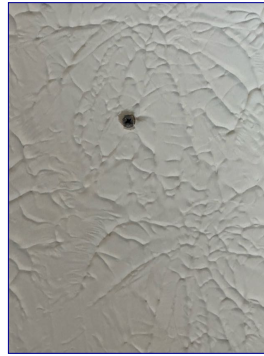
There are holes present in the wall/ceiling. Recommend repairing.

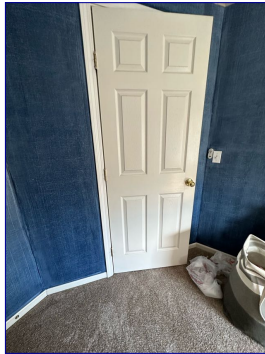
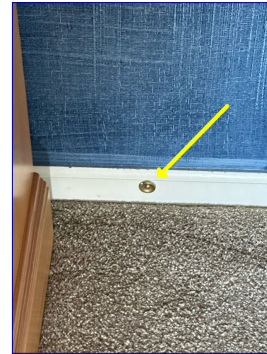
Recommend installing a doorstop. Doorstops help prevent damage to the wall from the doorknob.

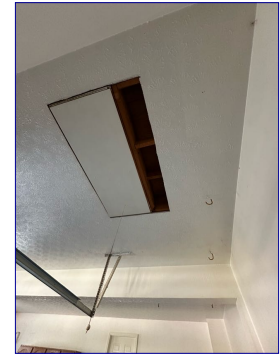
Garage attic access missing drywall around the pull down steps. Recommend drywall contractor to repair.

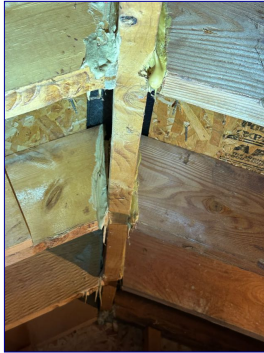
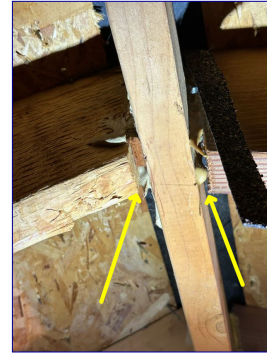
Rafters do not appropriately meet Ridge board. This can cause potential roof sag, and issues with rafters transferring the load properly. Glue and shims are used to connect the rafters. Recommend repair by qualified carpenter.

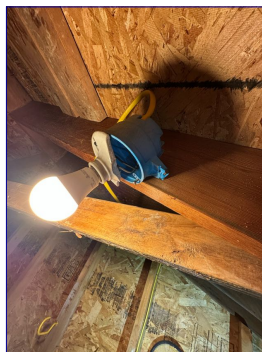
# Attic/Structure/Framing/Insulation (continued)

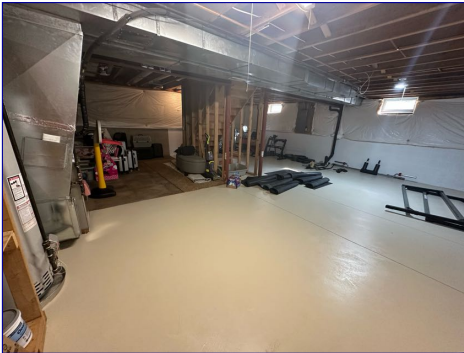
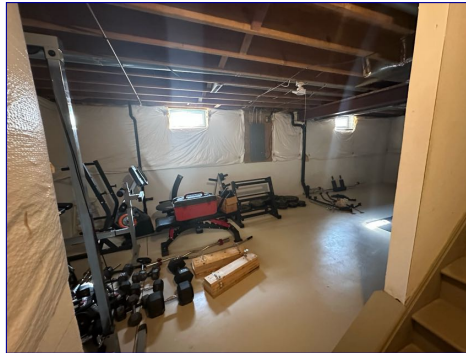
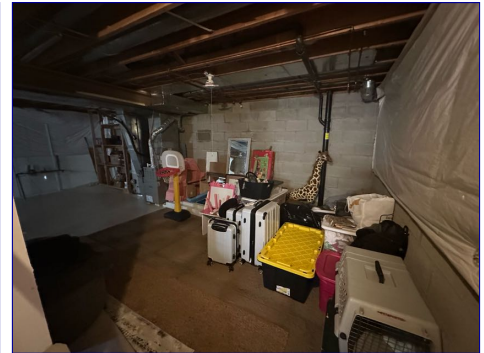
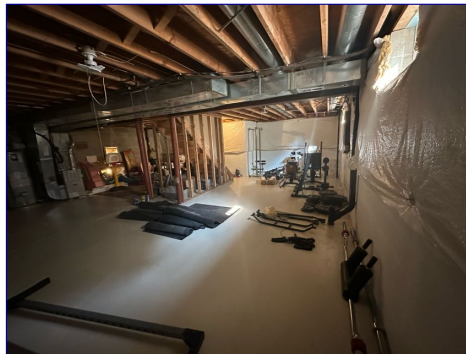
### 2. Basement Floor

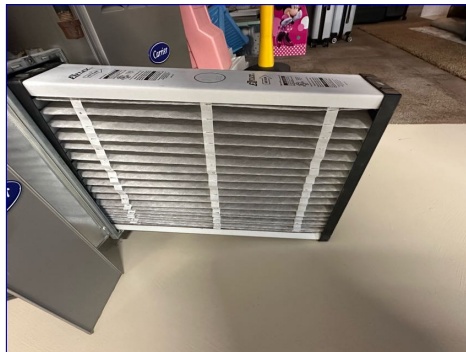
## 10. When Turned On By Thermostat

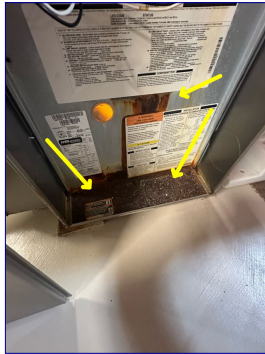
There is rust in the furnace. Recommend a licensed HVAC technician evaluate and repair as needed.

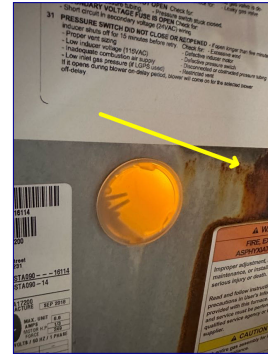
There is rust in the furnace. Recommend a licensed HVAC technician evaluate and repair as needed.

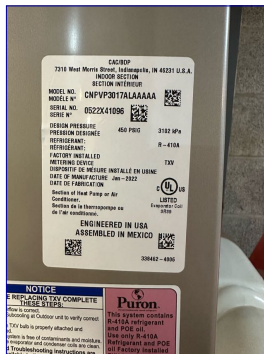
- The air conditioner coils data plate
